**ADDITION TO CORRECTIVE ACTION PLAN  
CAPA1-012822019  
SUBMITTED PURSUANT TO 4 CCR 723-7-7347(b)(VII)**

**January 28, 2019 Light Rail Derailment  
Response to Public Utilities Commission Request for  
Additional Information  
REGIONAL TRANSPORTATION DISTRICT-DENVER**

# Analysis Report

## Denver VII

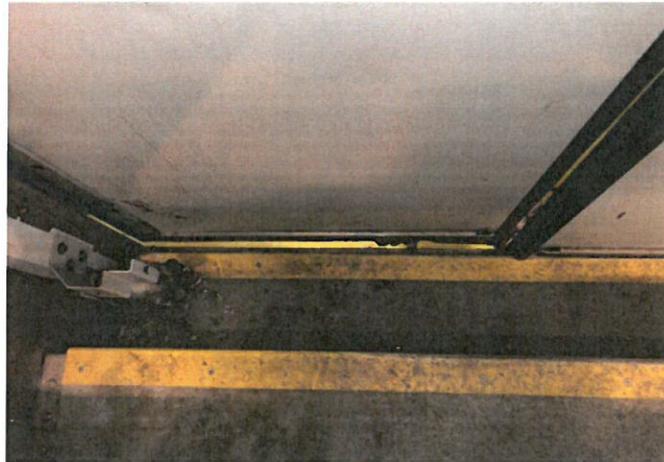
**Image 7: Stairs at door 1**

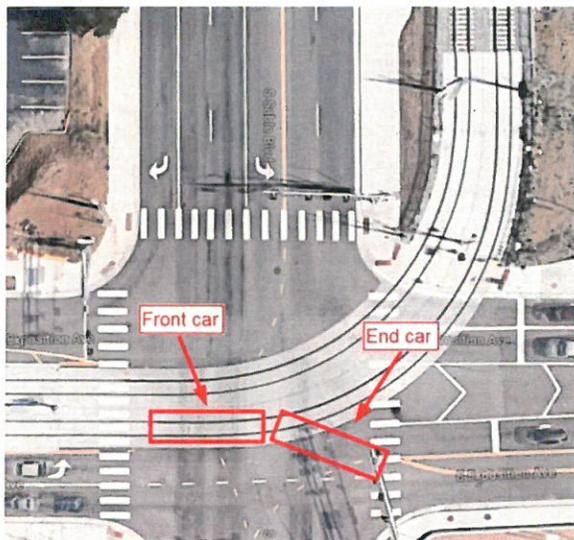
There was a second impact on Door 1 which is assumed to happen when the end car was sliding over the rails. According to RTD the threshold was bent to the inside of the vehicle during this impact so that the lower part of the left door leaf had direct contact with the street.

**Image 8: A-CAR sliding over rails**

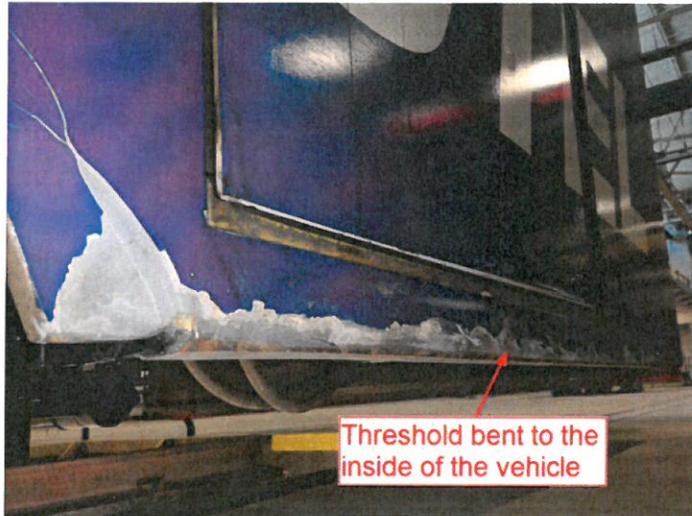
Image 9: Threshold of door 1

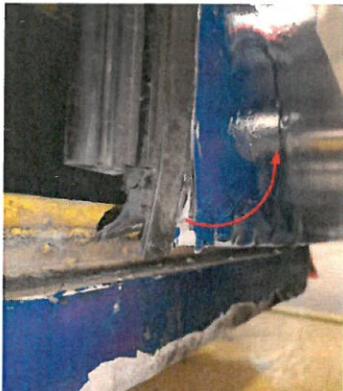
- The right door leaf of Door 1 rotated counter clockwise (view from outside) and pushed the support roller to the end of the elongated holes

Image 10: Threshold - Lower door leaf

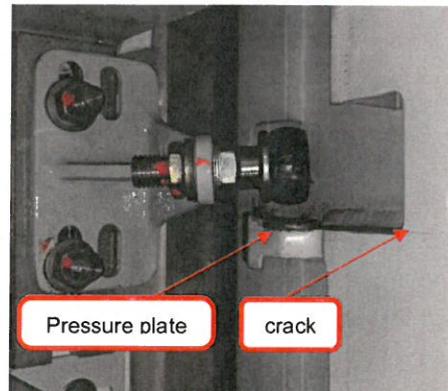
Image 11: Support roller with elongated holes

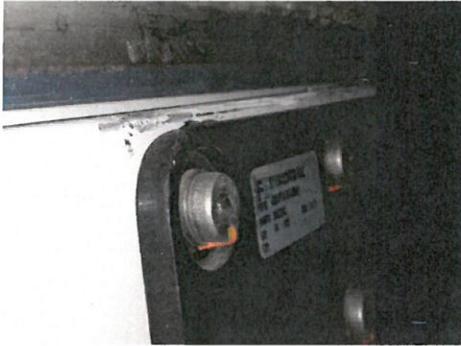
- Door leaf and door leaf carrier were twisted and collided with the upper sealing frame

**Image 12: Scratches on door leaf and carrier**

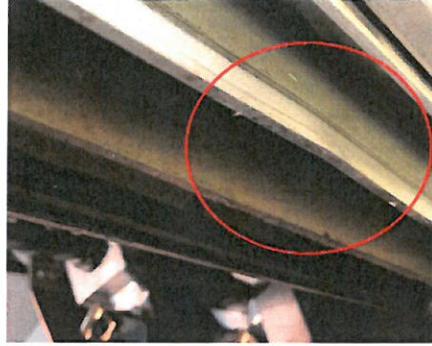
**Image 13: Bending on sealing frame**

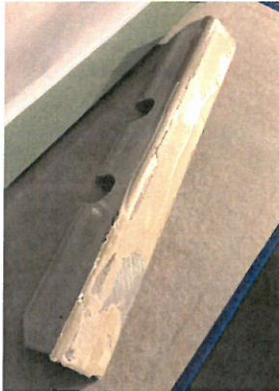
- Lower bracket (kick out protection which is installed to prevent vandalism by passengers) was ripped off by the roller swing arm

**Image 14: kick out protection**

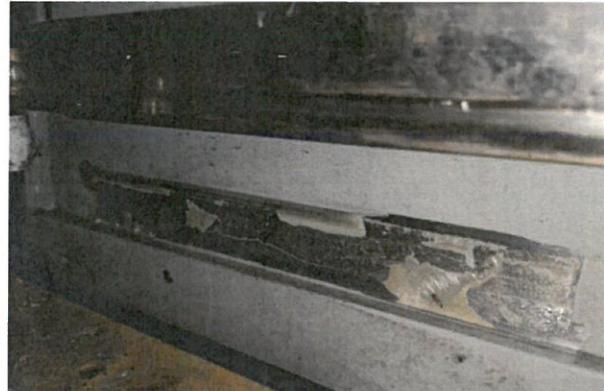
**Image 15: Bonding area of kick out protection on door leaf**

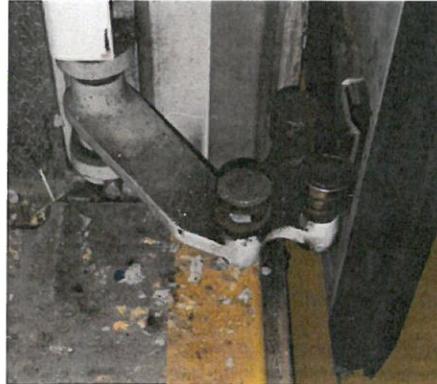
- The door leaf was lifted out from the roller swing arm and therefore had no guiding in the lower area anymore.

**Image 16: Door1 lifted out roller swing arm**

Due to the above described consequences of the accident a part of the woman's leg was exposed outside of the train, got trapped between threshold and street and was severed. When the leg was trapped between threshold and street the woman was pulled out of the train through the gap between threshold and the left door leaf (view from inside; see also)

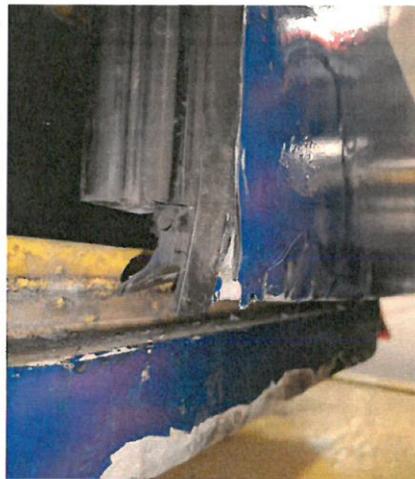
- No plastic deformation of the portal could be measured. (height, diagonal measurement)
- All mounting bolts of the drive unit were still in position (screw marking not cracked), only the marking of the left door leaf mounting bolts was cracked.
- Bolt markings on the trolley carrier were not cracked
- Door leaf guiding rail did not show any indication of movement due to the accident
- Even though the paint of the door leaf was cracked under the left door leaf carrier and at the pressure plate (see image 11) there was no deformations visible (flexible bending)
- The lower left door leaf area showed plastic deformation because of the collision with street

Image 17: Plastic deformation on left door leaf

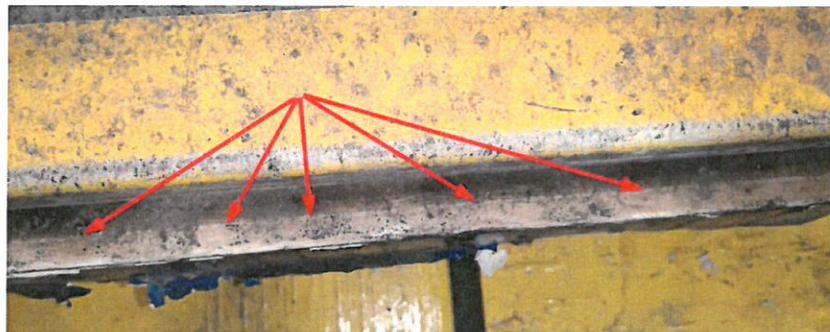
- Door leaves were in contact with the threshold during the first impact of derailment

Image 18: Threshold with mark of door leaf

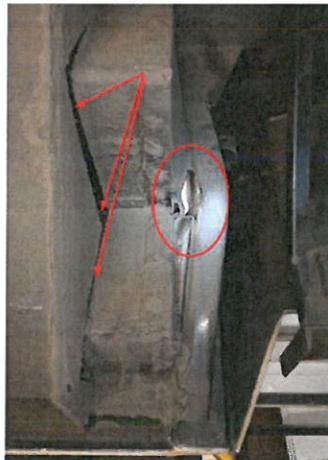
- All thresholds on the left side of the train made contact with the street and rails, most of the weld seams on the lower side of the thresholds were broken.

Image 20: Right portal side of threshold - broken welding seams

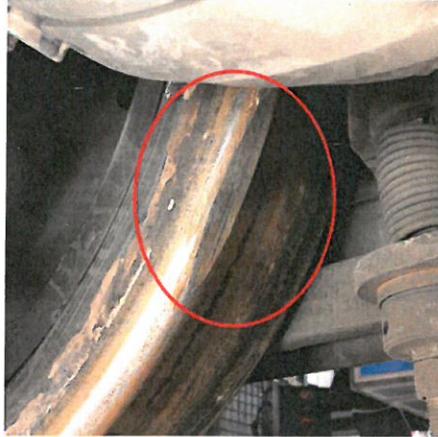
- The second wheel on the front bogie has a flat spot due to sliding over the street

**Image 21: Flat spot on wheel**

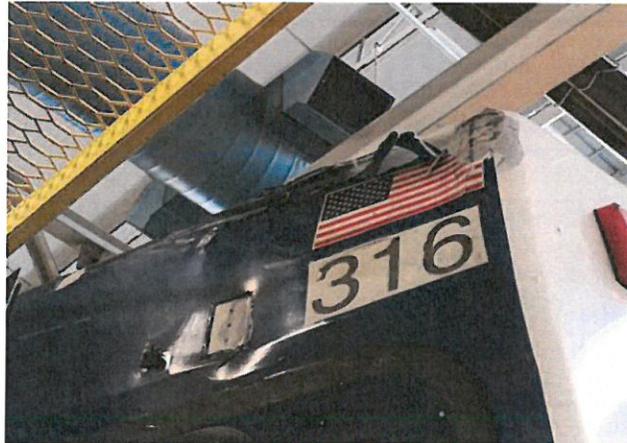
- Damage on the top of the end car due to collision with the light pole

**Image 22: Top of end car**

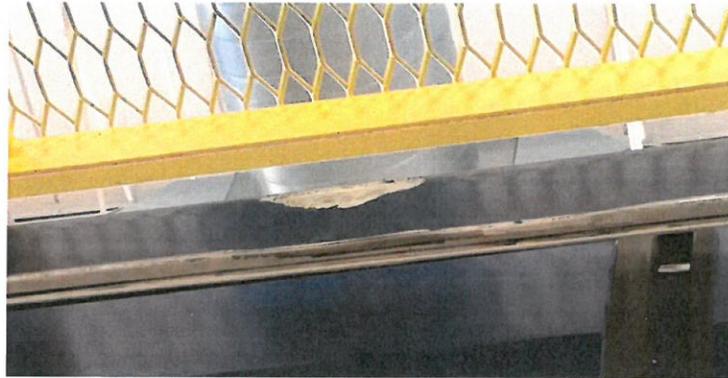
- Damage of the car body and rain water gutter above Door 1

**Image 23: Scratch above Door 1**

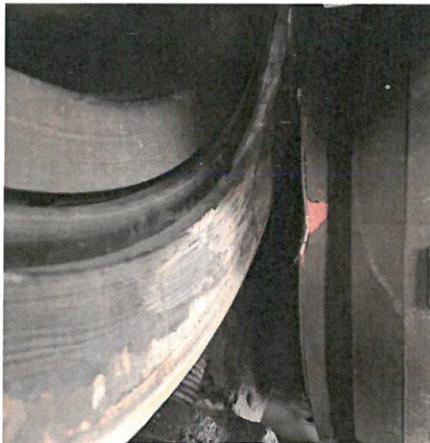
- Collision of end bogie with air compression tank

**Image 24: Damage on tank**

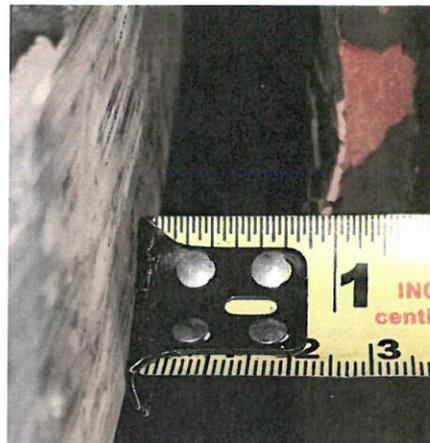
**Image 25: Measurement to tank**
