**ADDITION TO CORRECTIVE ACTION PLAN  
CAPA1-012822019  
SUBMITTED PURSUANT TO 4 CCR 723-7-7347(b)(VII)**

**January 28, 2019 Light Rail Derailment  
Response to Public Utilities Commission Request for  
Additional Information  
REGIONAL TRANSPORTATION DISTRICT-DENVER**

# Analysis Report

## Denver VII

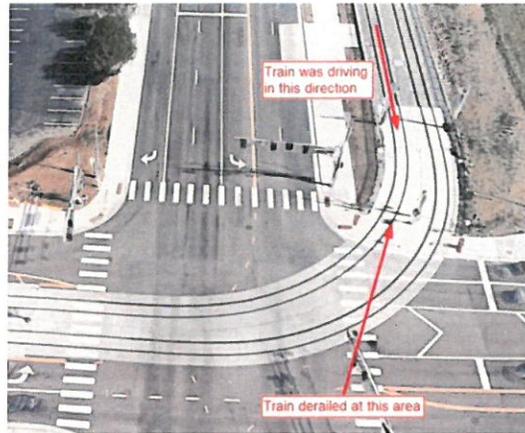
**Image 5: Accident location**

The front car (B car) was caught in the rails of the counter direction; the end car (A car) was sliding over the rails. During the derailment the train tipped on an angle and was sliding only on its outer wheels (train side of Door 1) and the door thresholds.
